Manhole Inspection Summary

Manhole # S710__015MH

Insp Date: **4/14/08 12:45 PM**

Location Address: **6720 Duluth Ave.**

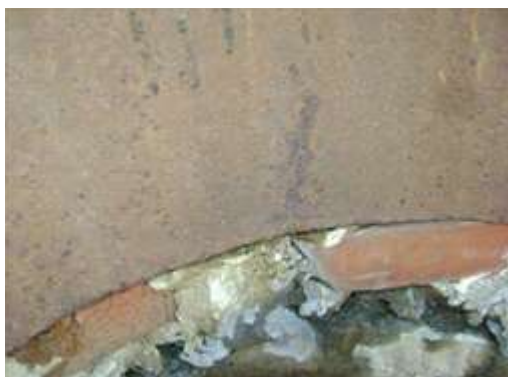
Defect 2

more cracks under frame

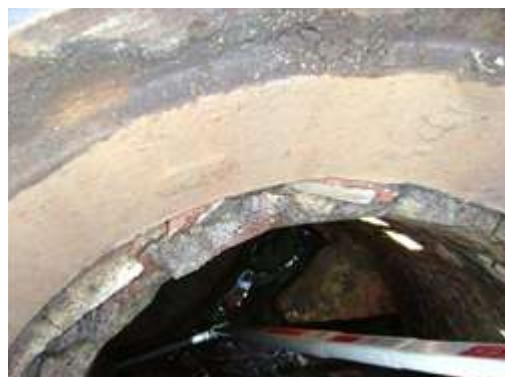
Defect 4

Offset: **2** (in.)

frame offset

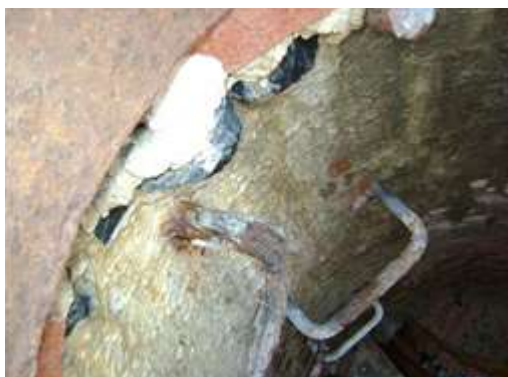
Defect 3

Comments **CRACKED PIPE SEALS ON INCOMING AND OUTGOING LINES. INFILTRATION EVIDENCE ON BARREL WALL FROM UNDER FRAME.**

Infiltration on chimney and barrel wall

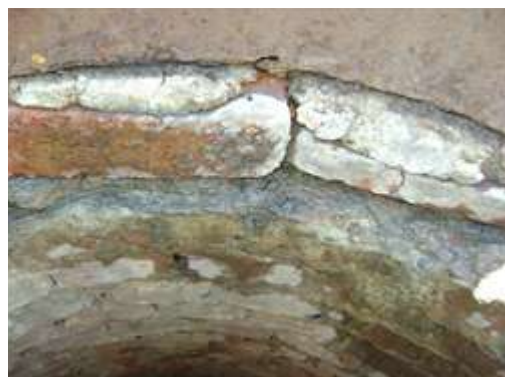
Defect 1

Condition: ☐ Sound ☐ Cracked ☐ Root Intrusion ☒ **Loose Brick** ☒ **Deteriorated**

cracked mortar in chimney under frame

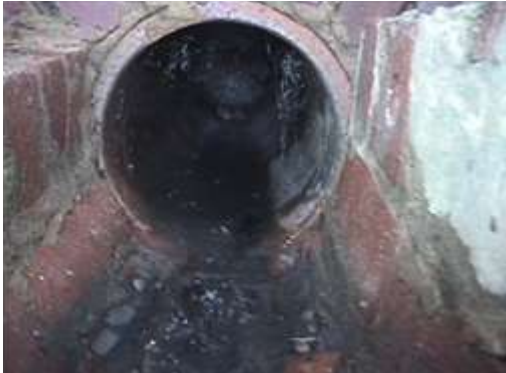
Defect 6

cracked pipe seal 11:00-2:00 on incoming
6 O'clock

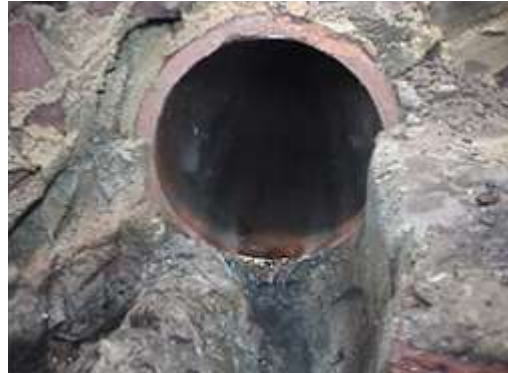
Defect 5

cracked pipe seal 9:00-11:00 on incoming
4 O'clock

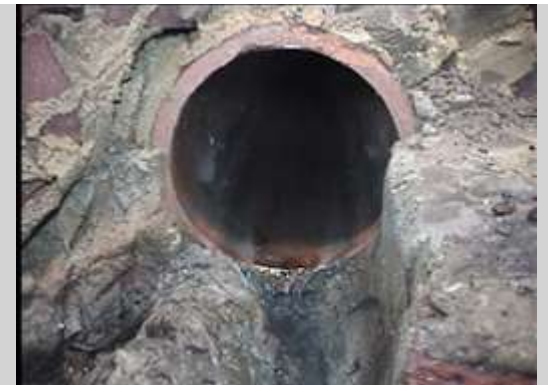
4 O'Clock Inflow

Pipe Height: **8.4** (in.) Rod and Bar (Angled)
Pipe Material: **Clay** ☐ Pipe Lined
Invert Depth: **7.50** (ft.) Flow Characteristics: **Slow**
Deposits: ☒ None ☐ Mud ☐ Sludge ☐ **Debris** ☐ Grease
Silt Depth: (in.) Deposits Extent:
Infiltration: **None** Pipe Seal Cond: **Cracked**

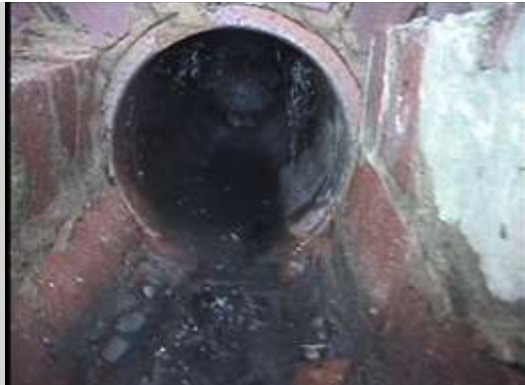
6 O'Clock Inflow

Deposits: ☐ None ☐ Mud ☐ Sludge ☒ **Debris** ☐ Grease

Silt Depth: **0.25** (in.) Deposits Extent: **Light**

Pipe Seal Cond: **Cracked**

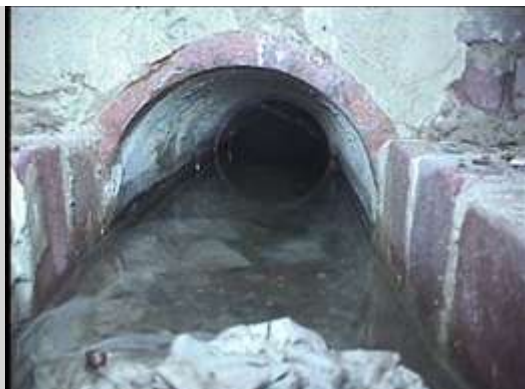
7 O'Clock Inflow

Deposits: ☐ None ☐ Mud ☒ **Sludge** ☒ **Debris** ☐ Grease

Silt Depth: **2** (in.) Deposits Extent: **Medium**
